Manhole Inspection Summary

Manhole # S31I__017MH

Insp Date: **10/29/08 1:31 PM**

Location Address: **301 s eutaw st**

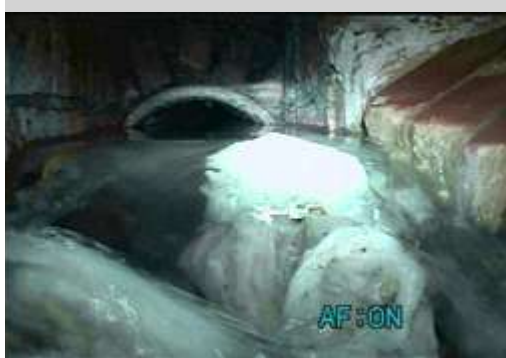
Defect 3

Condition: ☐ Sound ☐ Cracked ☐ Root Intrusion ☐ Deteriorated ☐ Leaks ☒ **Debris**

channel cond debris

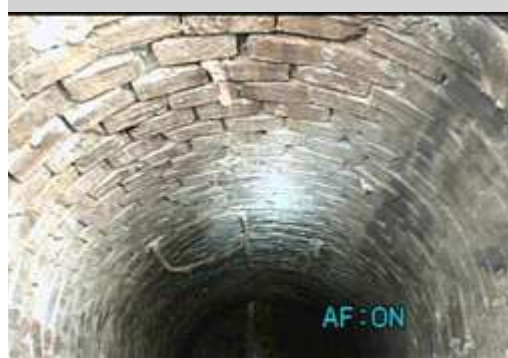
Defect 2

Condition: ☐ Sound ☐ Cracked ☐ Root Intrusion ☐ Loose Brick ☒ **Deteriorated**

Infiltration: ☐ None ☐ Joint ☐ Cracks ☐ Mortar ☐ Roots ☒ **Wall**

Count: **9** Missing: **6** ☒ **Corroded**

correl & barrel deteriorated with infiltration from wall; corroded/missing steps

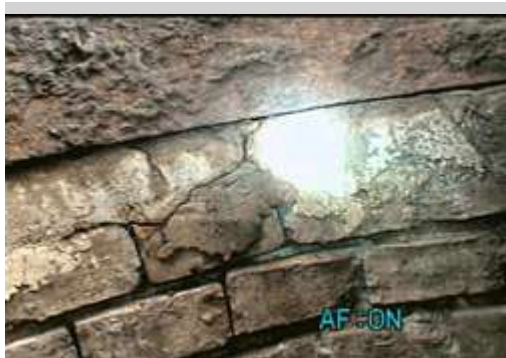
Defect 1

Condition: ☐ Sound ☒ **Cracked** ☐ Root Intrusion ☒ **Loose Brick** ☒ **Deteriorated**

chimney cond cracked, loose bricks, & deteriorated

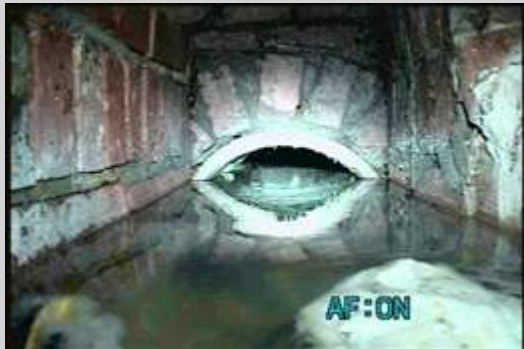
6 O'Clock Inflow

to much water do to channel debris
